PERFORMANCE INNOVATION LABORATORIES

**Failure Analysis of
Vibration Test Cards for Crane
Job ID: TOL0901051**

Report by: Eva Kosiba
Title: Operations Engineering Advisor

Company Name: Crane Division, Naval Surface Warfare Center (NSWC)

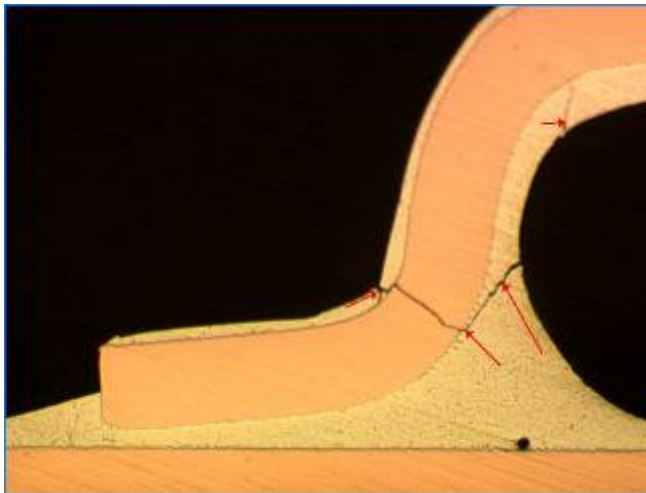
Figure 8: SN63 U41. Left lead

All of the TQFP-144 packages were fabricated using Sn finish on the leads, and four of the nine were exposed to one or two re-work cycles with SnPb solder. All of the solder joints experienced significant cracking. Additionally, eight leads broke, all corresponding to components that did not undergo any re-work and therefore contained only Pb-free solder.

SN63 U41 and SN61 U20 illustrate TQFP-144 packages which were not reworked and therefore contain only Pb-free solders. All of the components experienced broken leads on at least one side of the component, usually both.

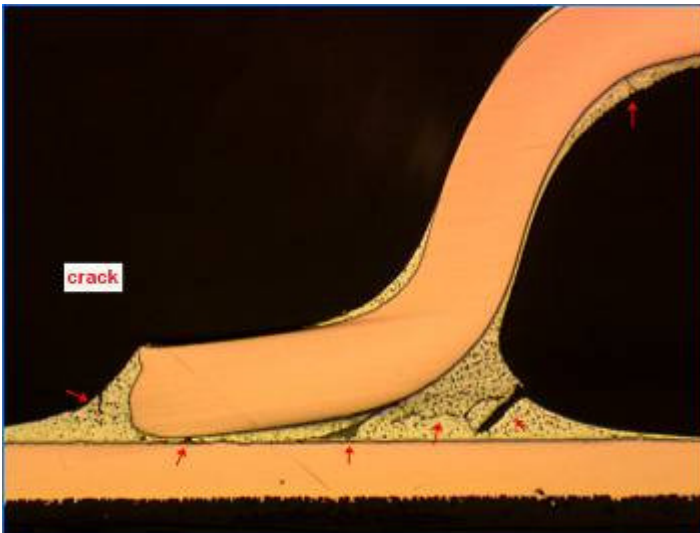
Figure 32: cross section, SN62, U31, left lead solder crack, 100x

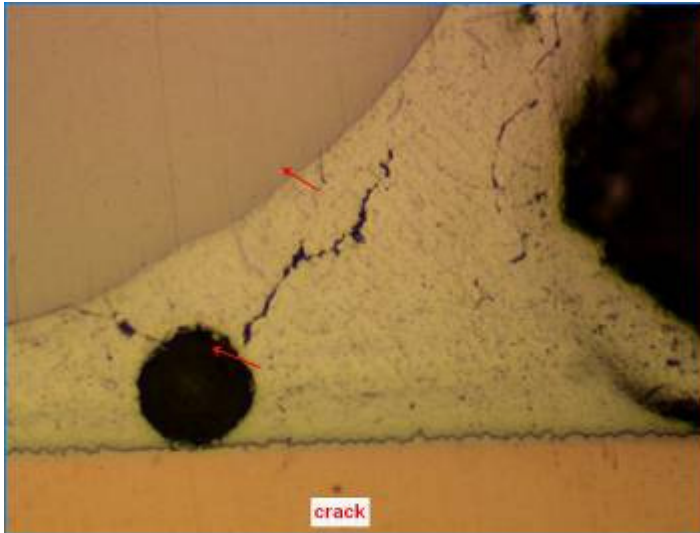
Figure 46: cross section, SN62, U61, left lead solder crack, 400x f

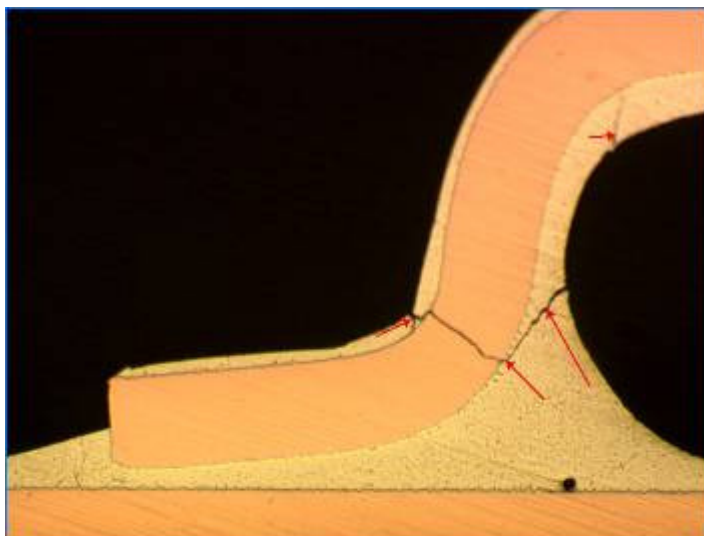
Figure 74: cross section, SN63, U41, left lead crack, 100x

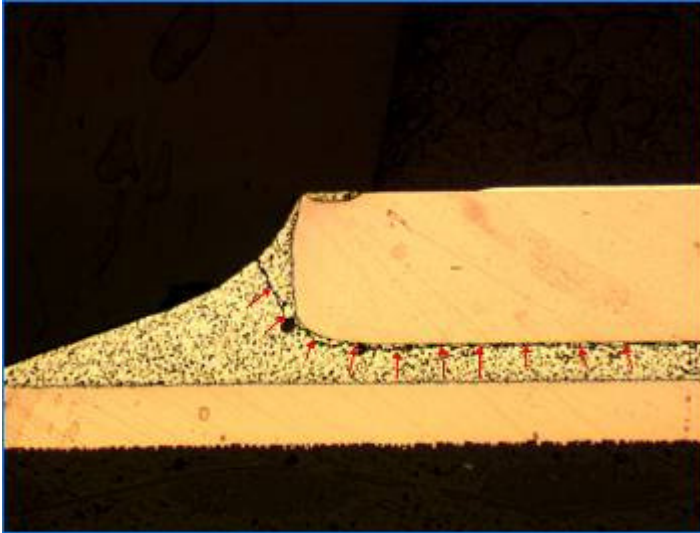
Figure 82: cross section, SN63, U54, left pad solder crack, 100x

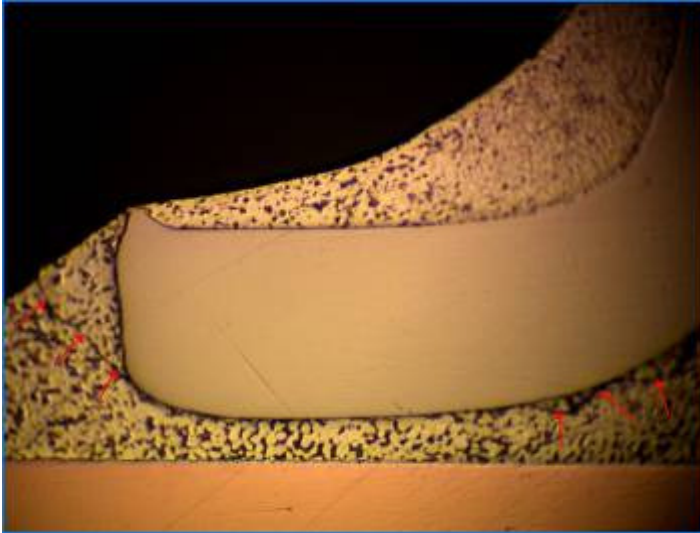
Figure 86: cross section, SN63, U61, left lead solder crack, 200xa

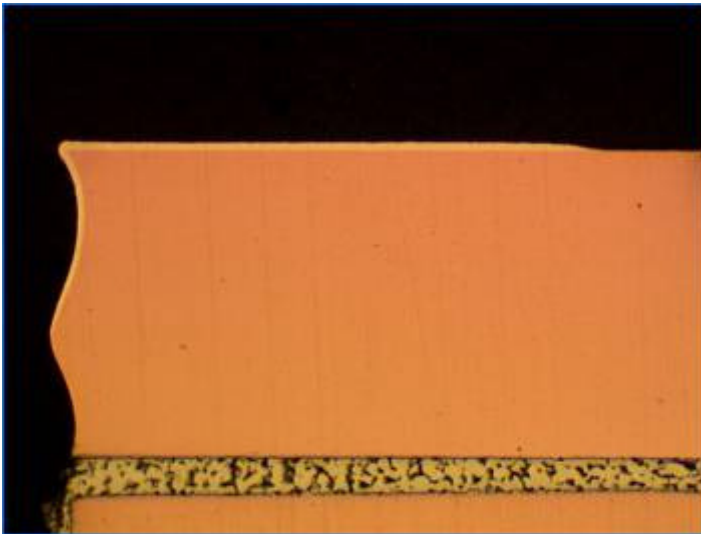
Figure 156: cross section, SN67, U54, right lead , 200xb
